The International Space Station and the Space Debris Environment: 10 years on

Nicholas Johnson¹, Heiner Klinkrad²

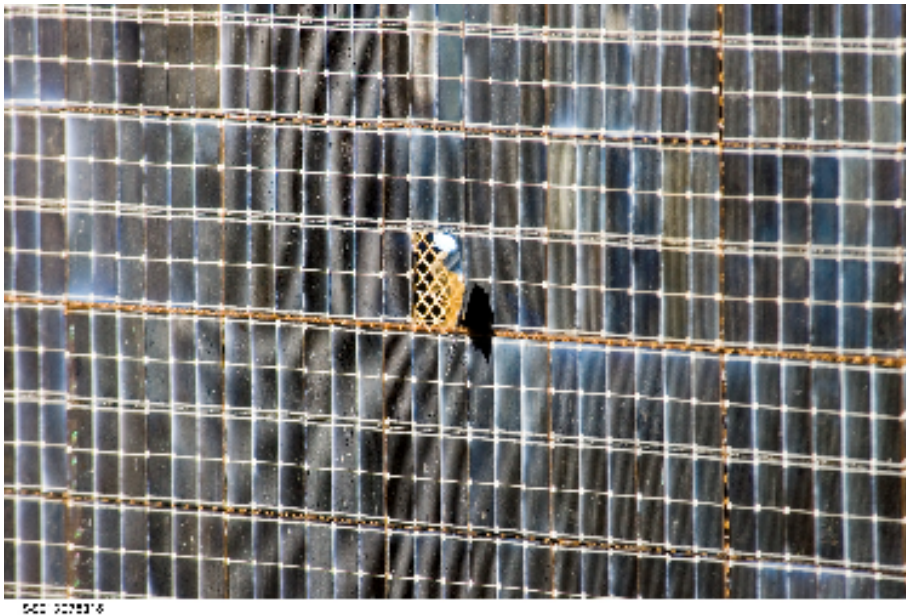
The multiple and expansive solar arrays represent the largest surface area of the ISS and, hence, the region where space debris impact damage would be expected. However, due to their distance from the core of the ISS and due to their high electrical potential, solar arrays normally cannot be closely inspected for evidence of small particle impacts. Figure 4 shows a segment of one ISS solar array which has apparently been damaged by a collision with a small particle. The design of the array ensures that the reduction in electrical power

Figure 4. Photograph made in 2006 of solar array damage from an impacting particle.

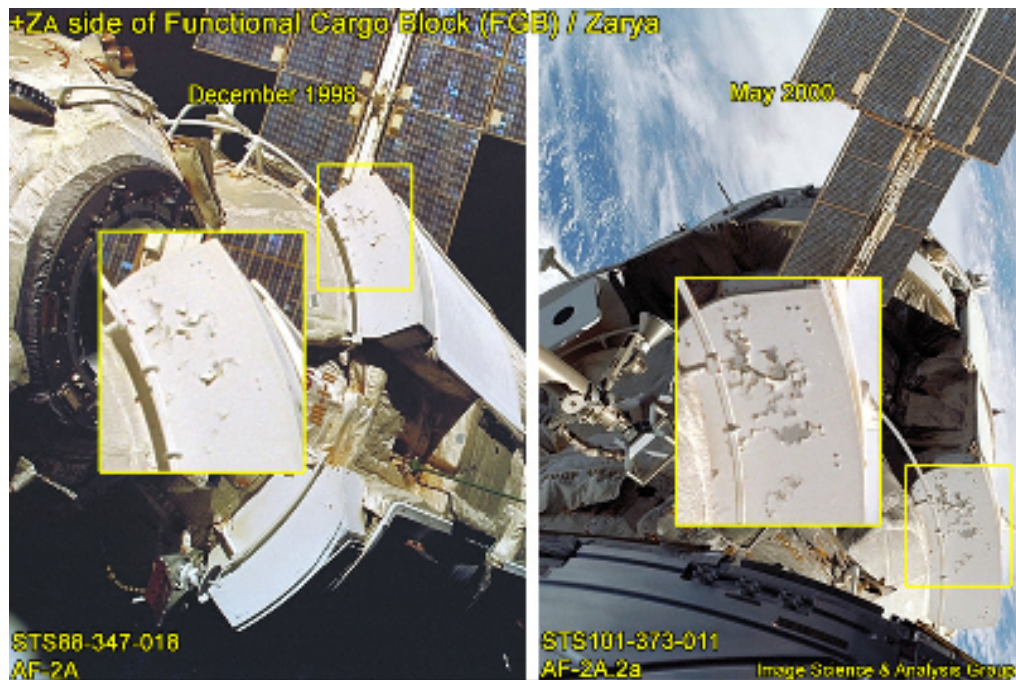
Some surfaces of the ISS are painted, and over time this paint can degrade and become brittle due to the harsh space environment, including direct solar radiation and extreme thermal changes when the ISS moves from daylight to night and back again during each revolution about the Earth. Figure 5 indicates the breakdown of paint on a portion of the Zarya module and how it increased from 1998 to 2000. Once paint becomes brittle, small particle impacts can knock flakes of paint off the surface, which in turn become short-lived orbital debris.

Figure 5. When paint becomes brittle from space environmental effects, small particle impacts can cause flakes to be released, becoming short-lived orbital debris.

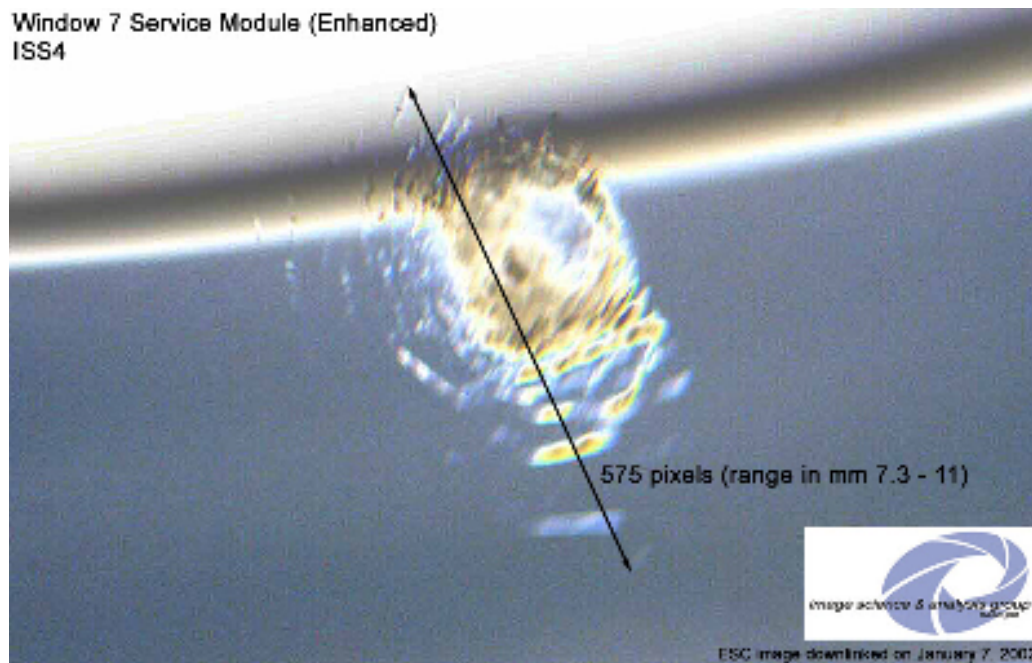
Another type of surface on the ISS on which space debris impacts can easily be detected is the windows. Figure 6 depicts a particle impact crater recorded in 2002 on one of the windows of the Zvezda module. An impact on another Zvezda window was more serious and led to the installation of a protective opaque cover over the window inside the module (Reference 2).

Figure 6. Impact crater found on the Zvezda module.

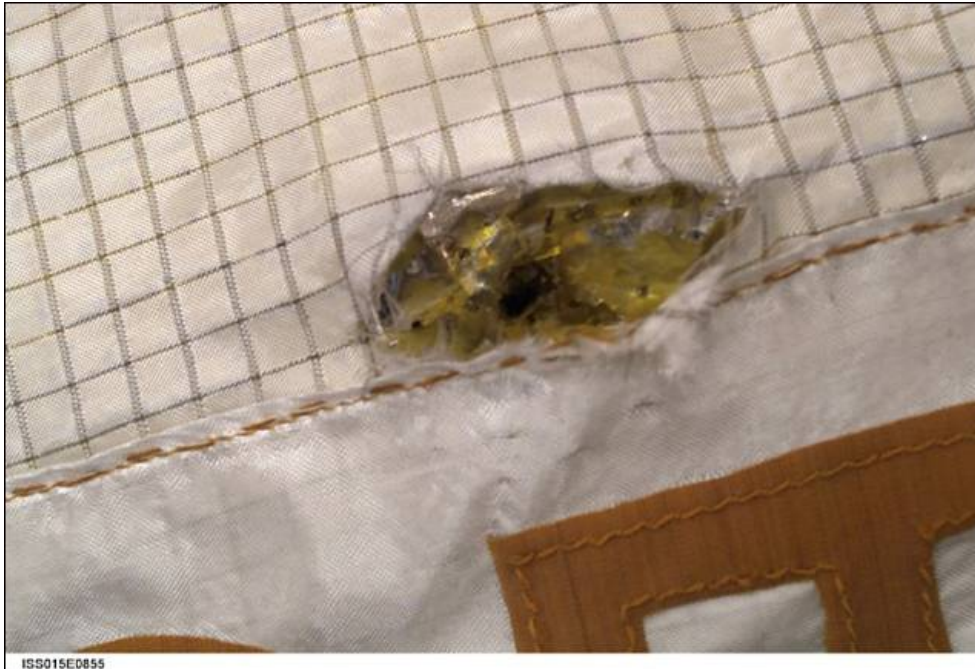
EVA's have revealed several areas of damage due to space debris impacts. One of the most prominent impact sites was found in 2007 on the Zarya module (Reference 3). A substantial tear (6.7 cm long and 3.3 cm wide) was discovered in a thermal blanket near the forward end (Figure 7). The nature of the damage suggests an impact from an oblique angle. From laboratory tests at the Hypervelocity Impact Technology Facility of the NASA Johnson Space Center, specialists believe that the impactor probably was 0.2 to 0.3 cm in diameter and penetrated not only the thermal blanket, but also the underlying steel mesh, fiberglass, and aluminum honeycomb layers. Fortunately, the compressor immediately underneath appears to have been untouched.

Figure 7. Tear in thermal blanket of the Zarya module due to space debris impact. Each square of the blanket is ~ 1 cm by 1 cm.

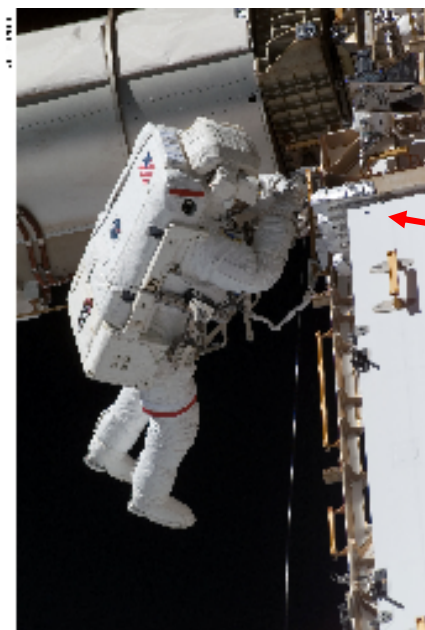
**Space debris
impact site**

Also in 2007, a crew member noticed a hypervelocity impact crater while working near a large aluminum panel (Figure 8). The following year craters were found on a handrail adjacent to the U.S. airlock and on an EVA tool which was stored externally on the Z1 truss of the ISS (Figures 9 and 10; Reference 4). Although the crater on the handrail was small (~ 2 mm in diameter), its sharp edges are now thought to have possibly been the source of cuts found previously on the gloves of crew conducting EVA's from that airlock. The particle which struck the EVA tool has been assessed to have been slightly less than 1 mm in diameter.

Figure 8. Space debris impact site discovered on ISS panel.

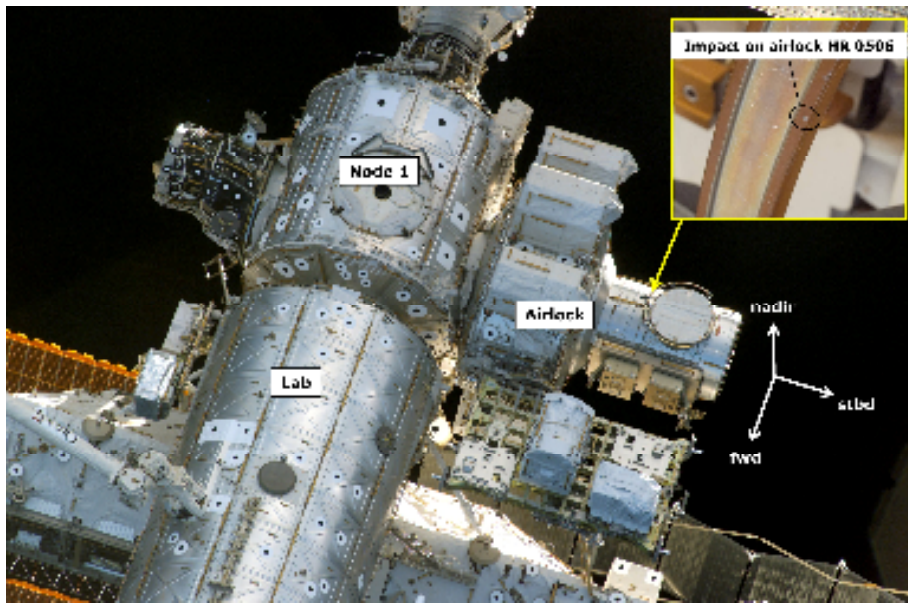
Figure 9. Impact crater discovered on an EVA handrail in early 2008 (Reference 4).

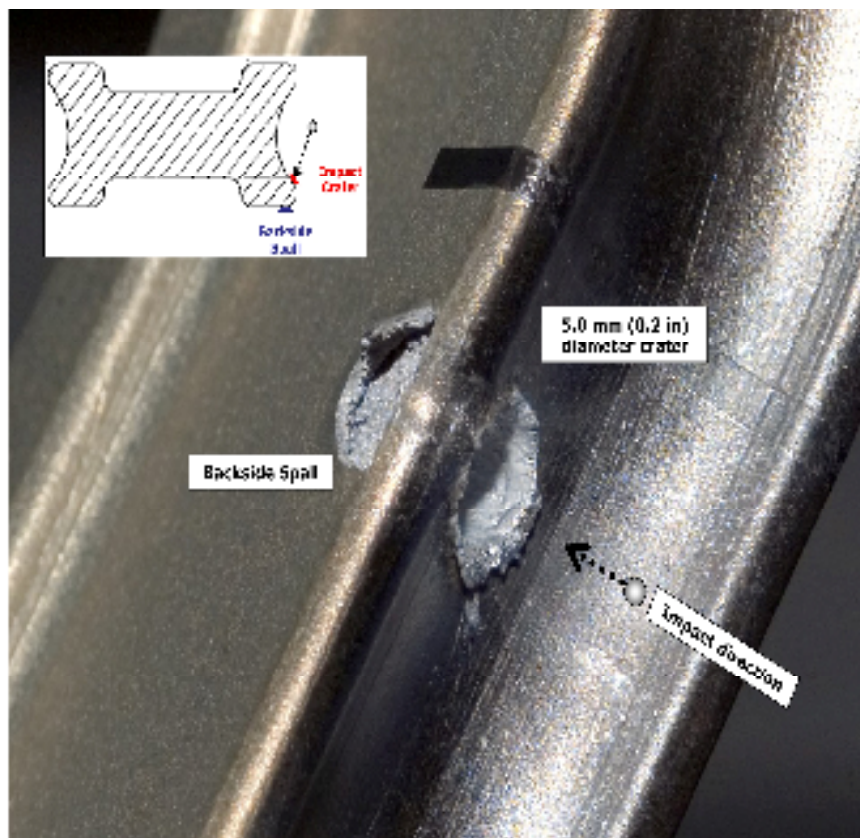
Figure 10. Impact crater and backside spall found on an externally stored EVA tool (Reference 4).

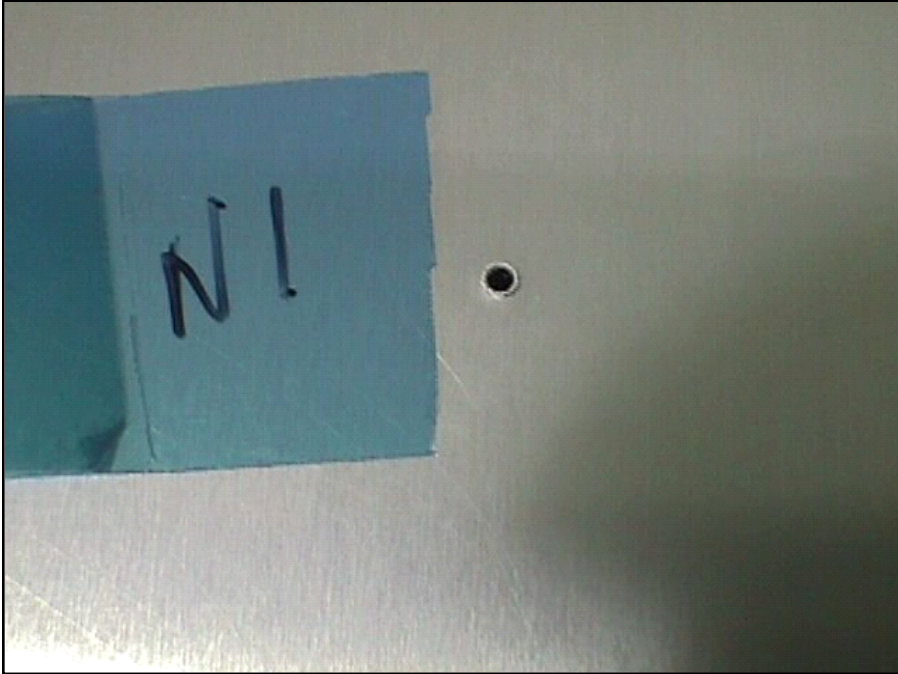
The first five missions involving an MPLM resulted in an exposure time of more than 700 hours and two instances of penetration through the outer aluminum bumper (References 5-6). On the maiden flight of the MPLM, a paint particle with an estimated diameter of ~0.5 mm left a 1.4 mm diameter hole in one of the bumper segments (Figure 11). After the fourth flight of an MPLM, a 1.2-mm diameter hole was discovered in the space debris shield, the victim of an impact by a stainless steel particle with a diameter assessed to be 0.2 mm.

Figure 11. Hole found in the space debris shield after the first flight of the MPLM to the ISS in 2001.
